**State Preservation Board**

**Texas Capitol Roof Replacement and Rehabilitation Update 5/2/2023**

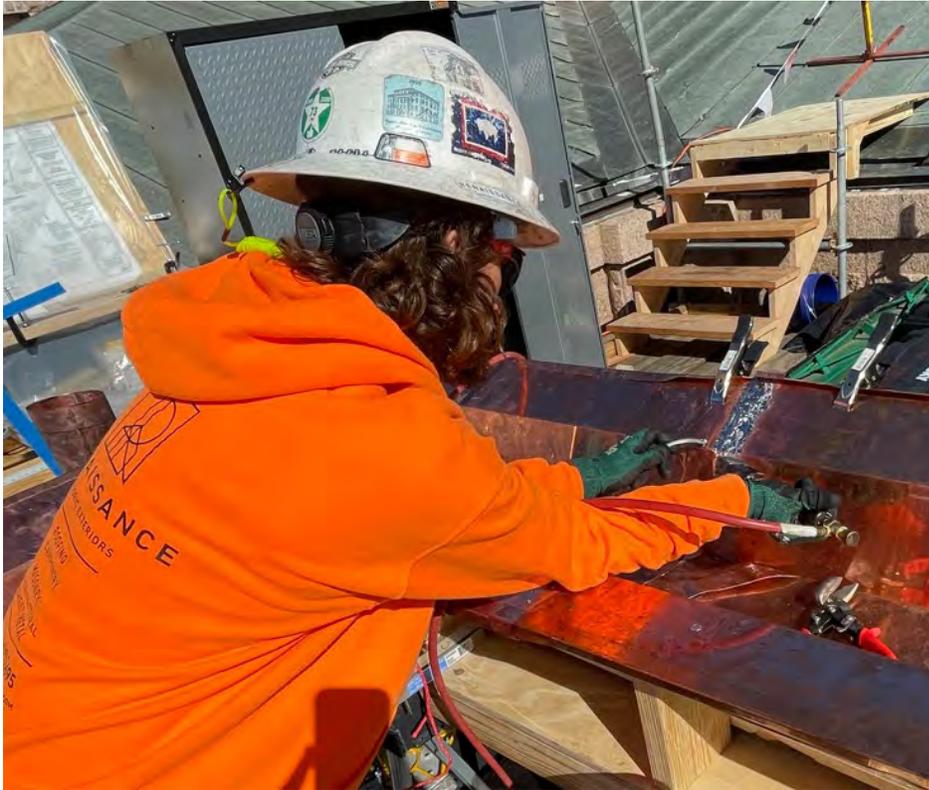
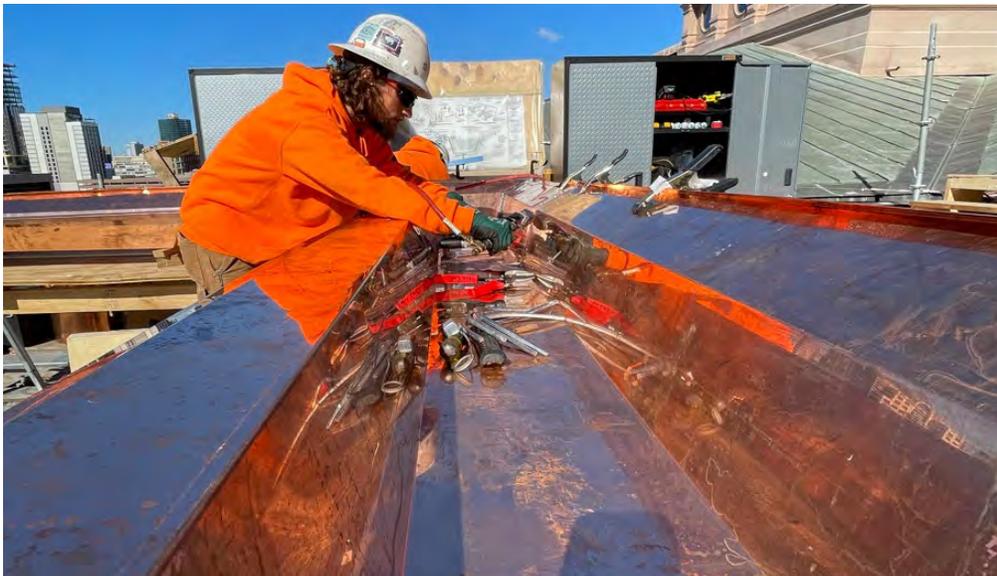
The gutter at the center and south wings is largely done.

Certified solderers are carefully sealing each joint in the metal to make them watertight.

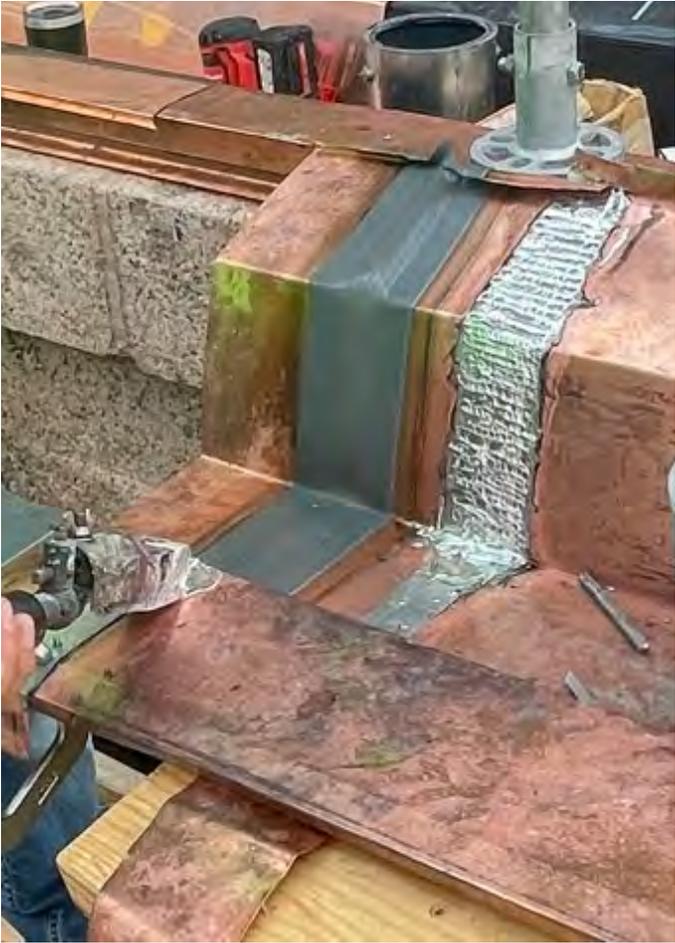
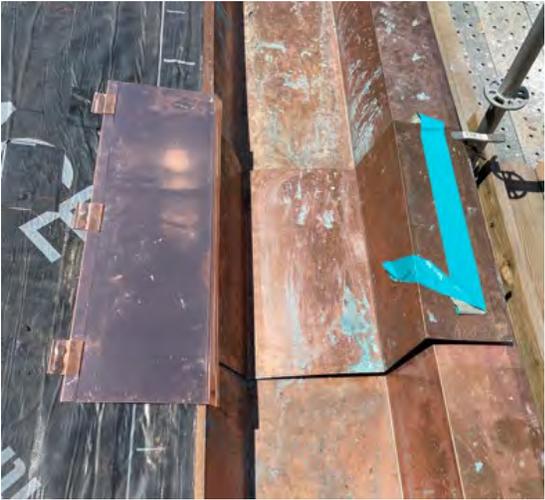
Special joints are required in the gutter to allow for movement, since adding downspouts in the historic granite walls is not feasible. These are being protected from UV, hail, and pests with removable covers which allow for inspection. These are expected to last 25-50 years, but will be one element of the roof requiring replacement before the rest of the copper roof.

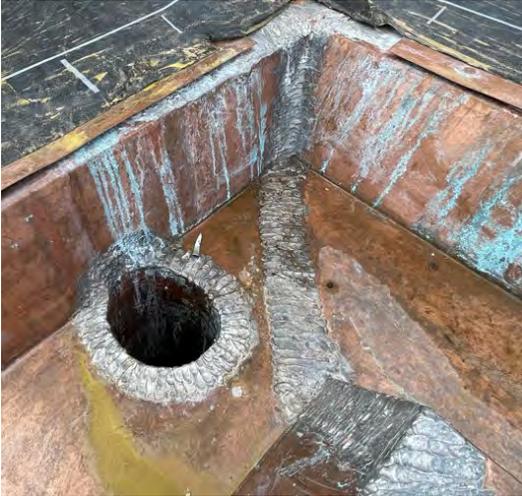
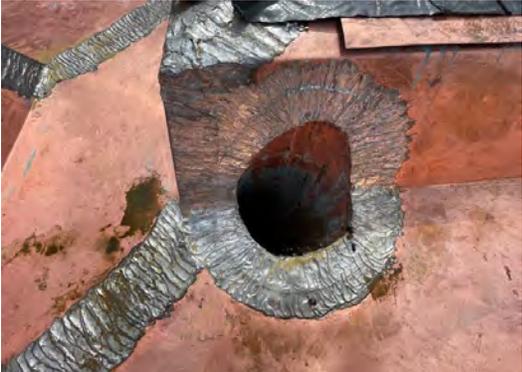
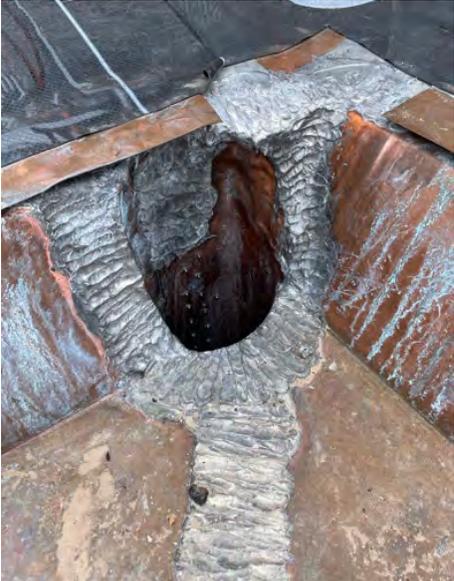
Some of the downspouts fall in inconvenient locations relative to the gutter, requiring custom fabrication at each location to tie them in.

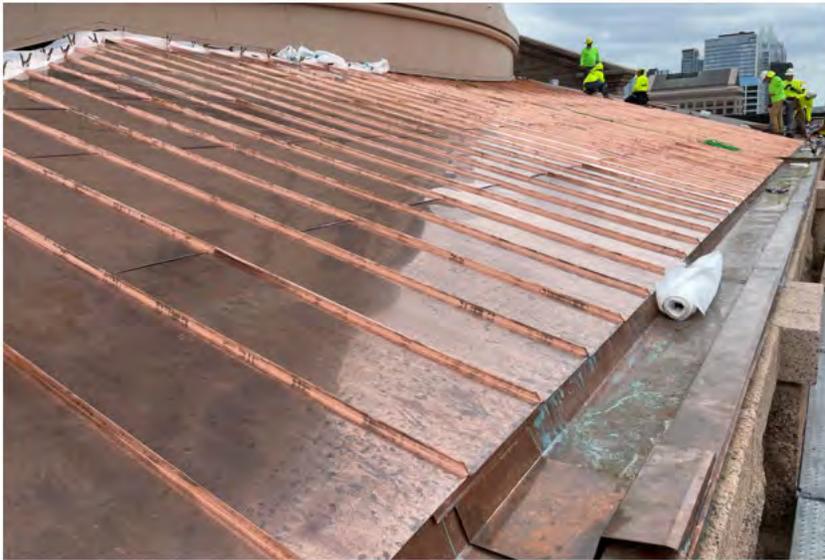
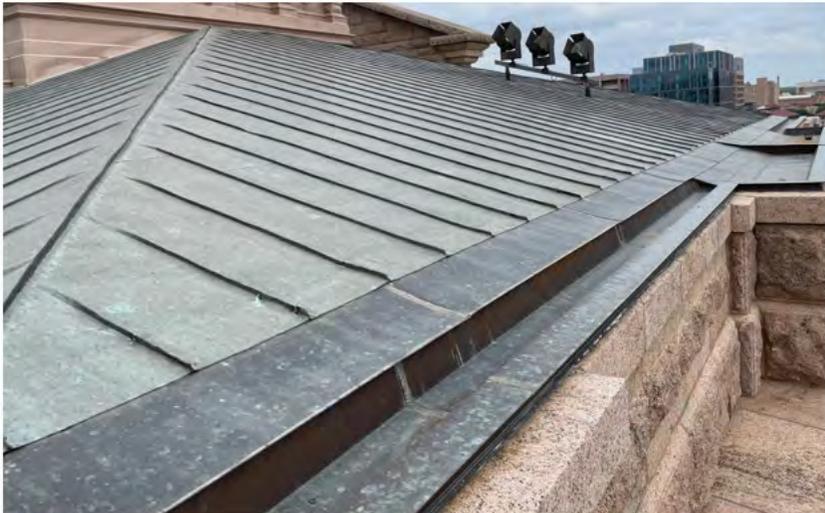
The new standing seams will be about ¼" taller than those on the 1949 roof, on average, to meet modern industry standards and prevent water from penetrating these mechanically closed joints. The older joints have also been bent and beaten down by 75 years of foot traffic and hail. That difference is more noticeable than the other main difference: that the current pans are 18" wide, while the 1949 pans were 21" wide. Again this applies modern standards for a more durable roof. (The 1888 pans were 24" wide, which may be part of the reason the roof leaked on opening day.)

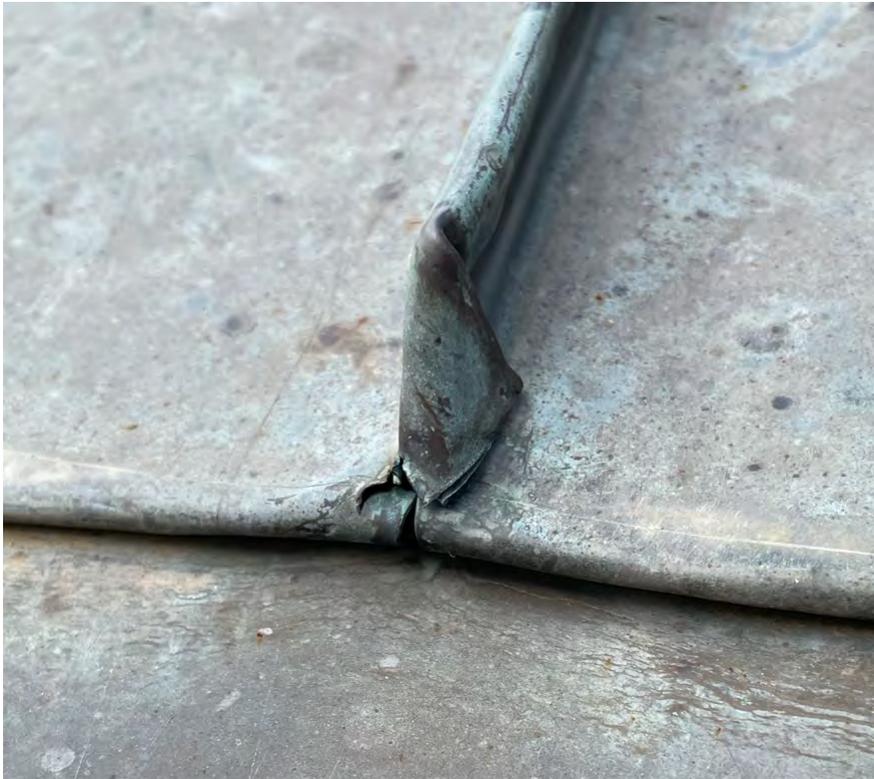
An improvement on the 1949 roof, which left open gaps at the end of each seam.

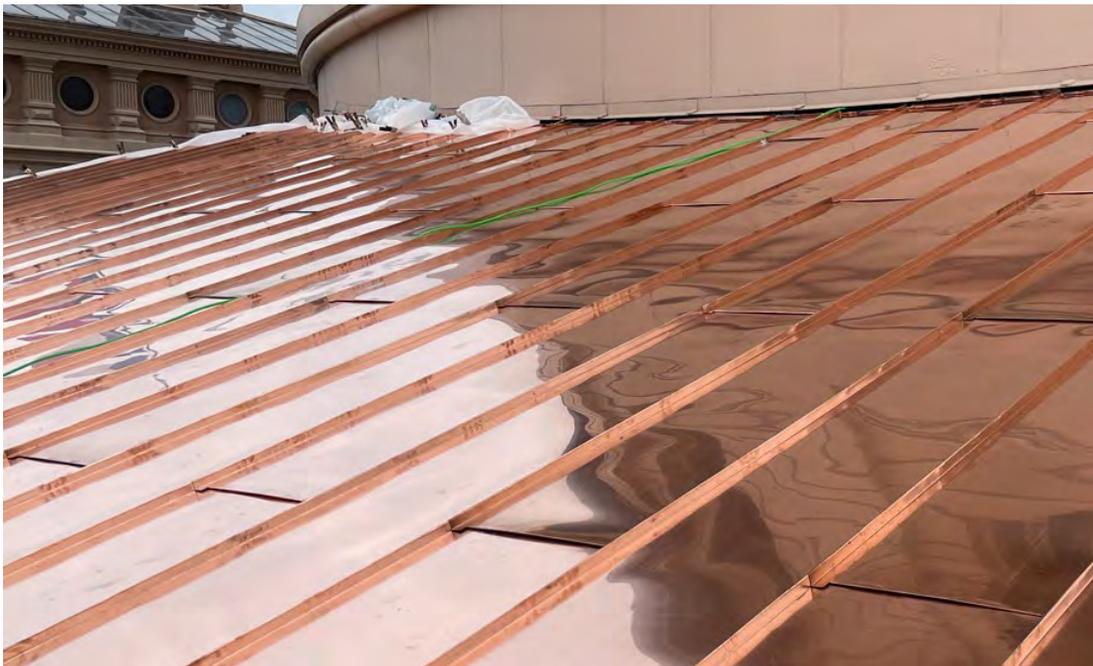
The new seams are 6” deep and slightly open to allow for movement, while still preventing wind-blown rain from penetrating the metal sheathing.

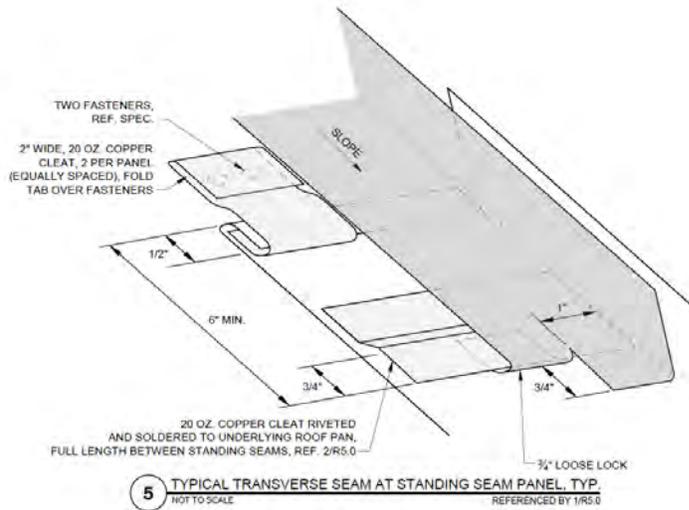
While these look like open gaps, they have a fully soldered cleat  $\frac{3}{4}$ " inside the seam, raised and clamped seams at the sides, and 6 inches of space to capture any water that may be driven in the narrow gap at the sides.

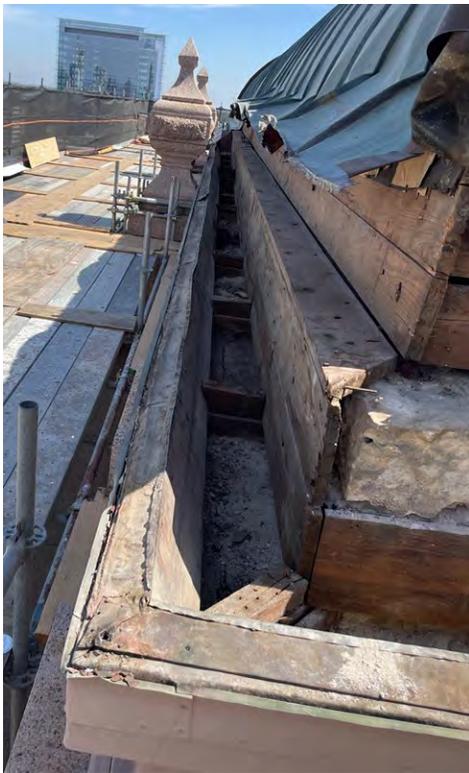
The opportunity is being taken to improve uplift resistance on the structure, which currently is 1888 wood framing in rubble limestone masonry.
