Old General Land Office Building/Capitol Visitors Center

Exterior Preservation and Roof Replacement

Project Update: 1-2-2024

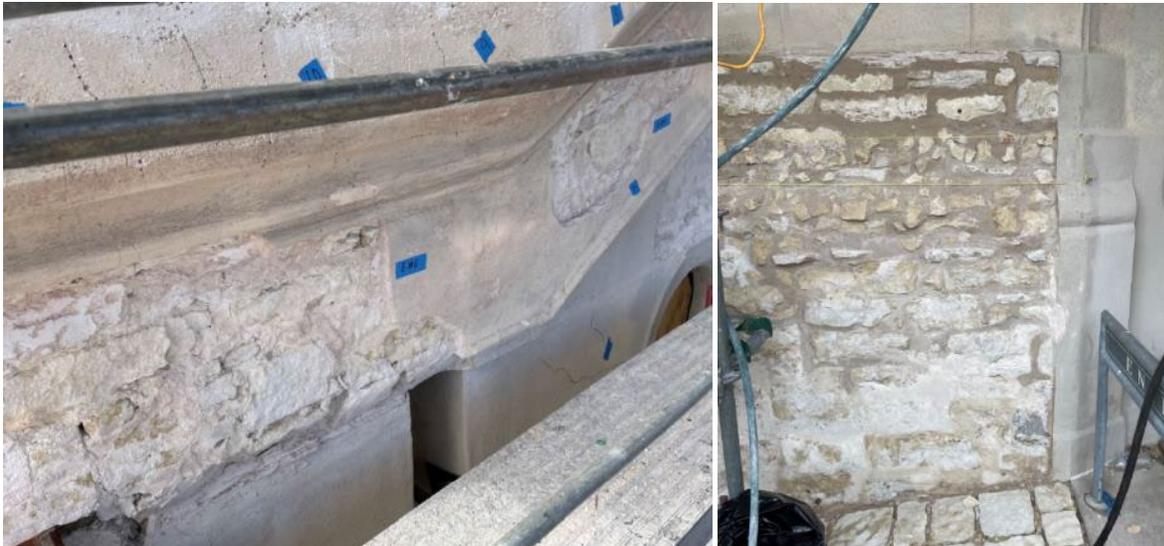
The remainder of the stucco requiring repair has been removed on the East and North facades. Blue painters tape is used to number each repair for preservation tracking.

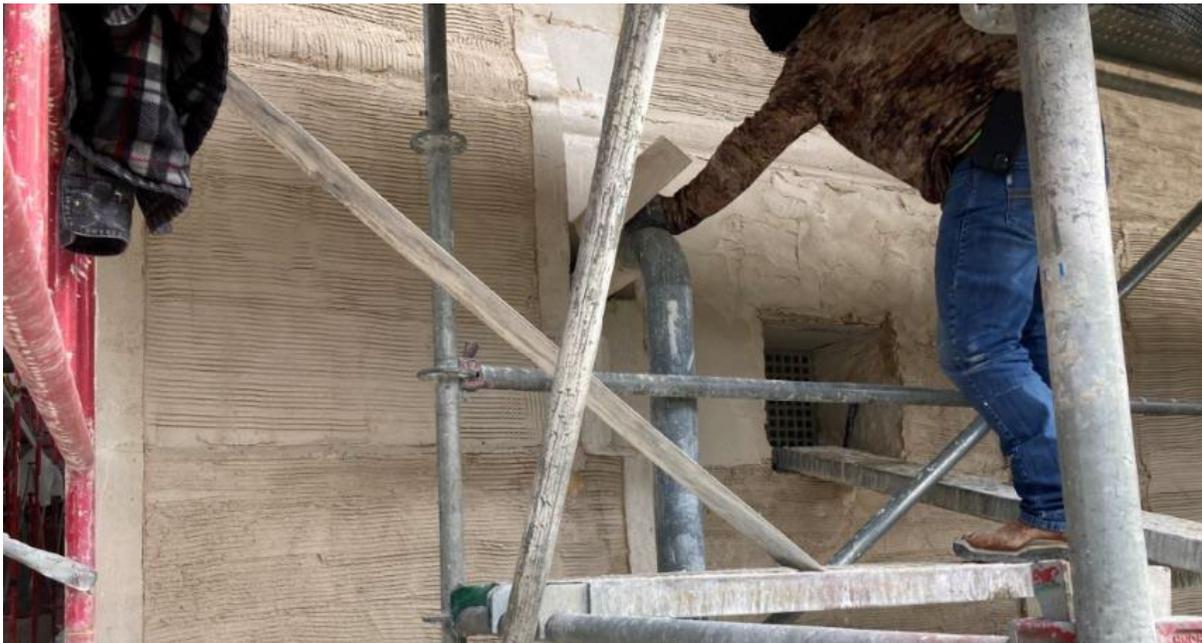
Stucco finish coats are being applied on the South façade.

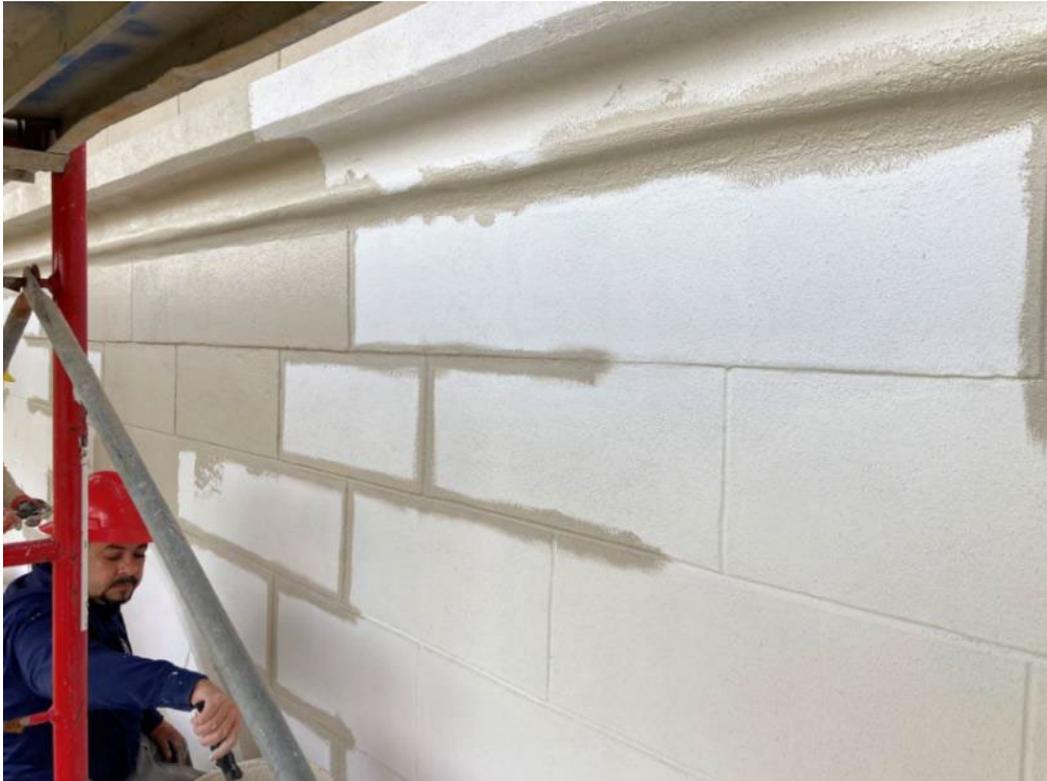
Here, painters are applying the first top coat after the primer has cured. They use a brush on all of the horizontal and vertical lines to accentuate the faux mortar joints in the stucco.

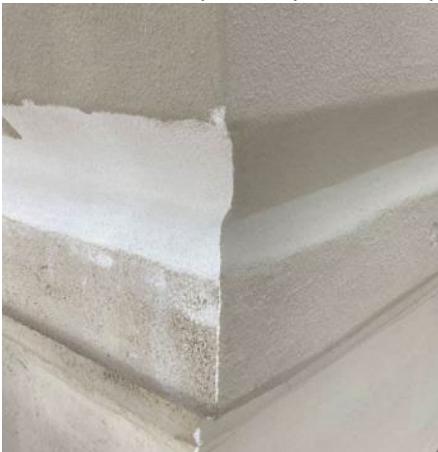
Three stages of paint work on the project. 30 year old paint ready to be primed on the bottom, white primer in the middle, finished paint topcoat on top, and to the right.

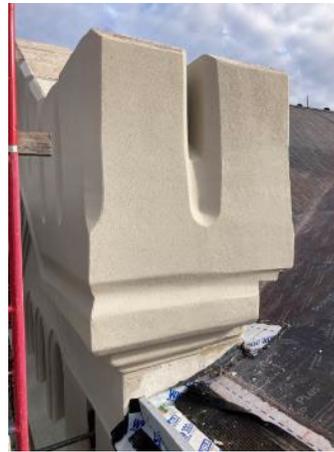
Fully painted crenellation

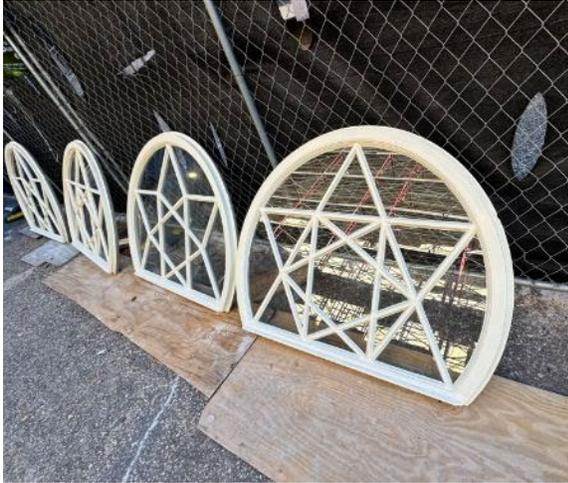
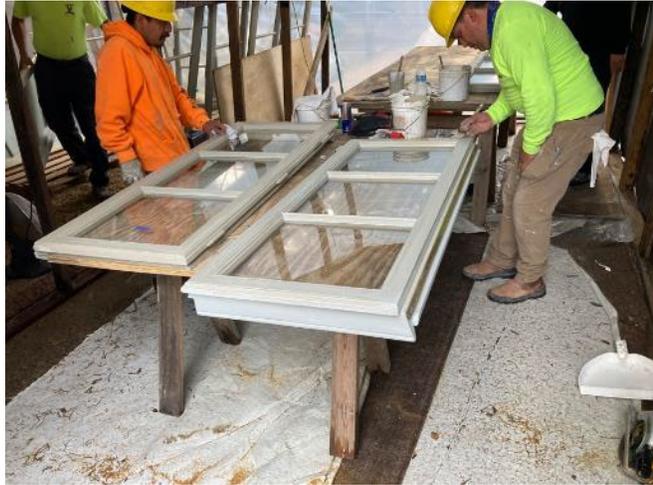
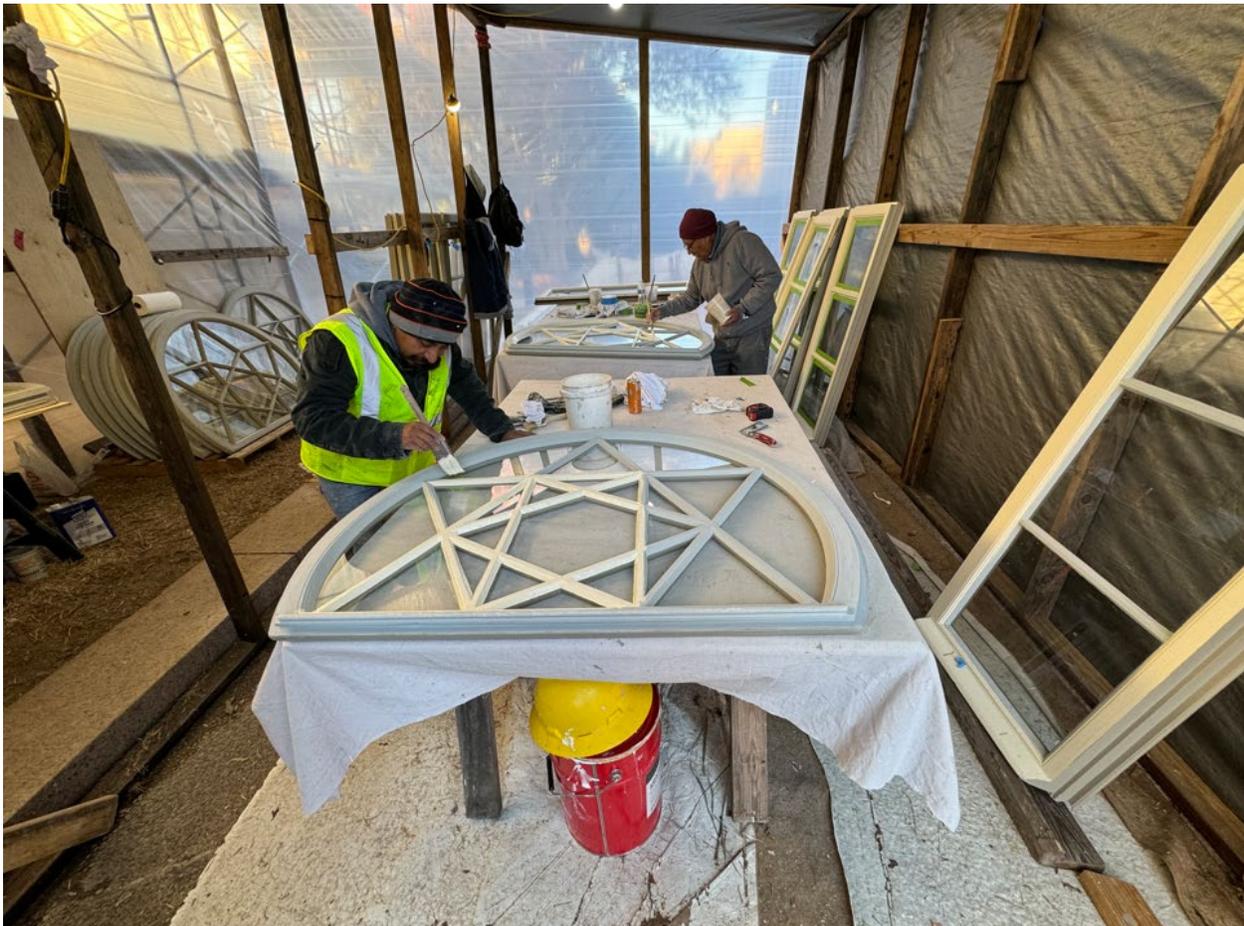
Window restoration is moving forward. Windows have been stripped, primed, and reglazed. The wood restoration contractor is in the process of applying the final coat of painting in preparation for UV film application prior to final install.

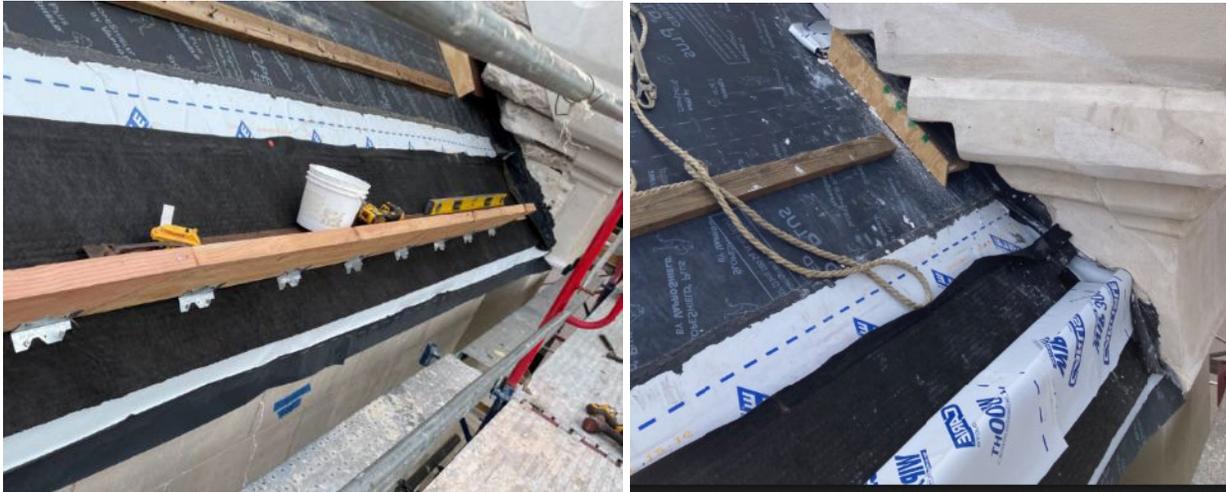
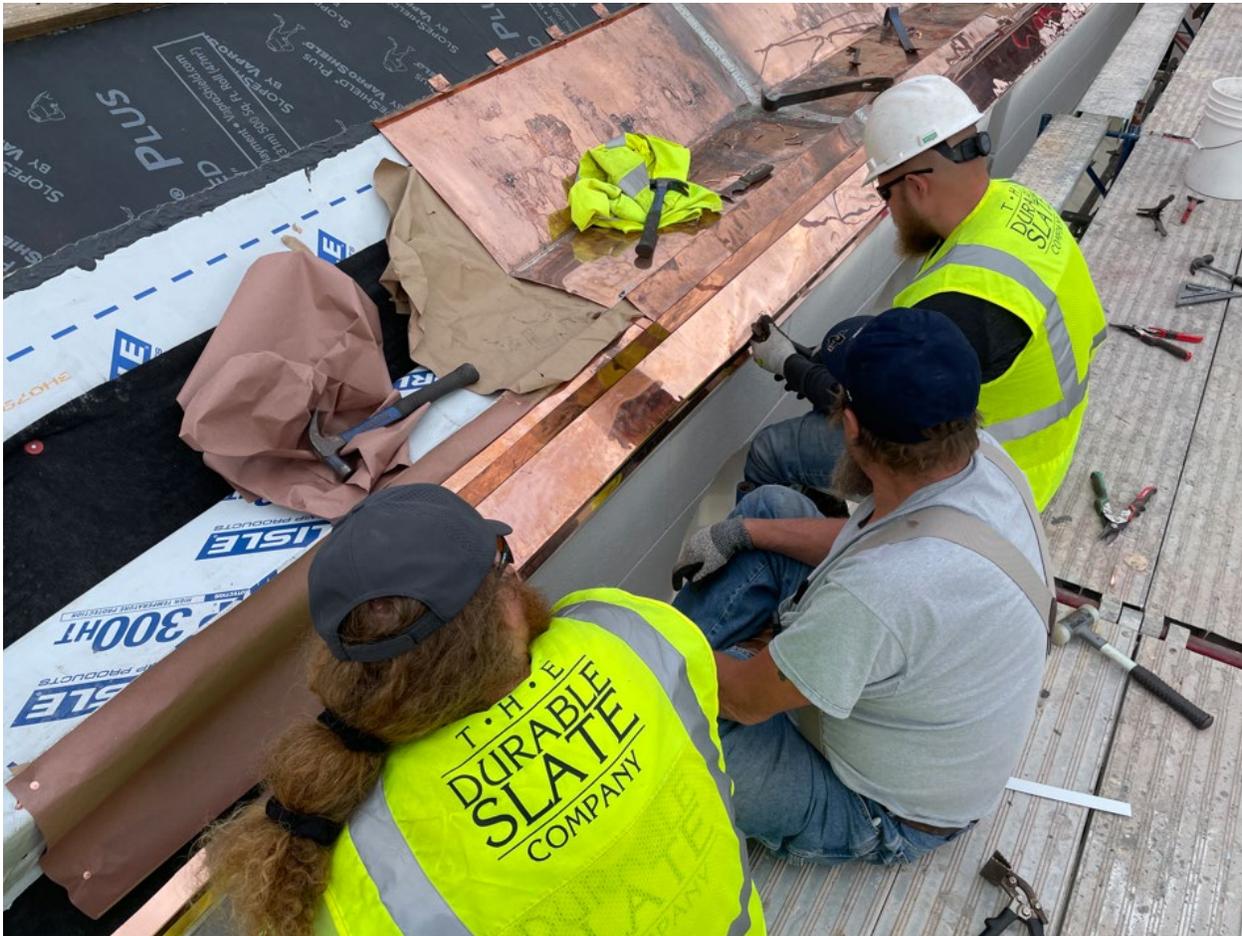
Roof carpentry preparing for the south pole gutter has been installed and wrapped with waterproofing. Copper is secured in place by either soldered or “locked” (crimped) joints.

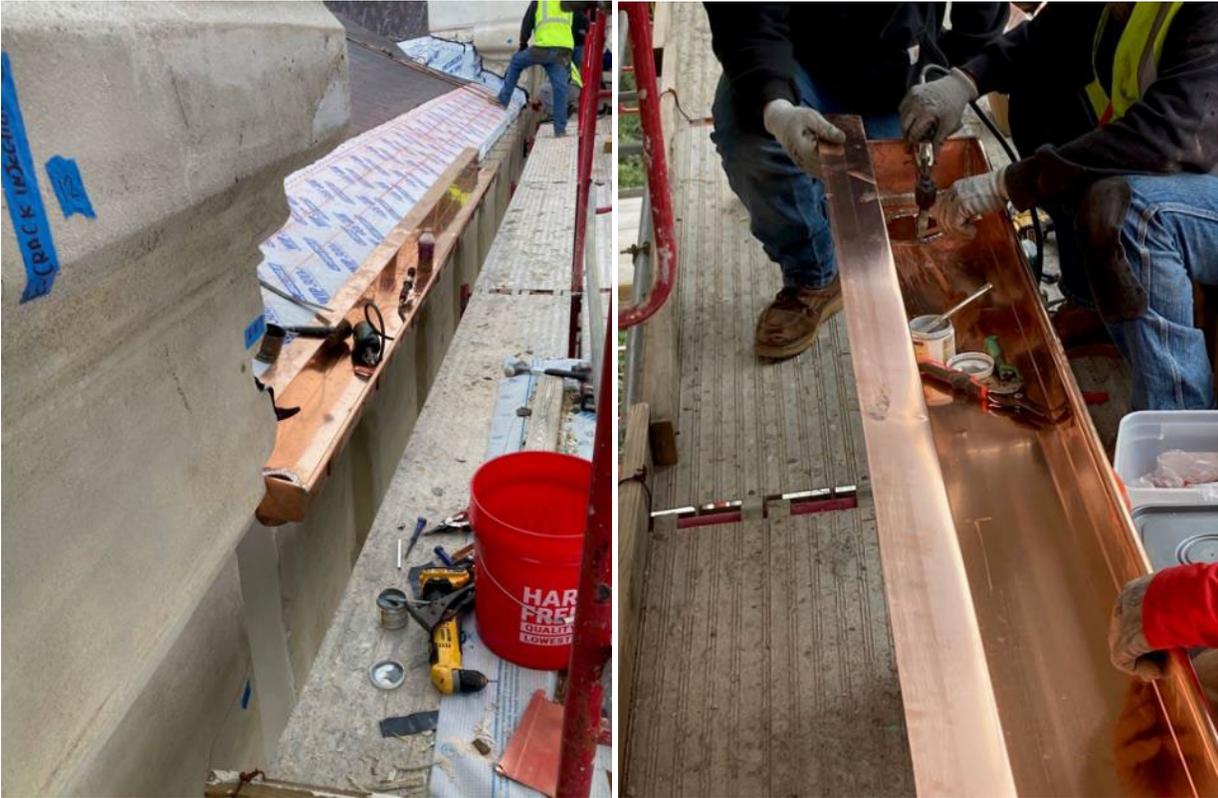
The hanging gutter on the east has been installed. Copper roofing metal specialists are soldering connections at the seams of the gutter and the downspout outlet tubes.

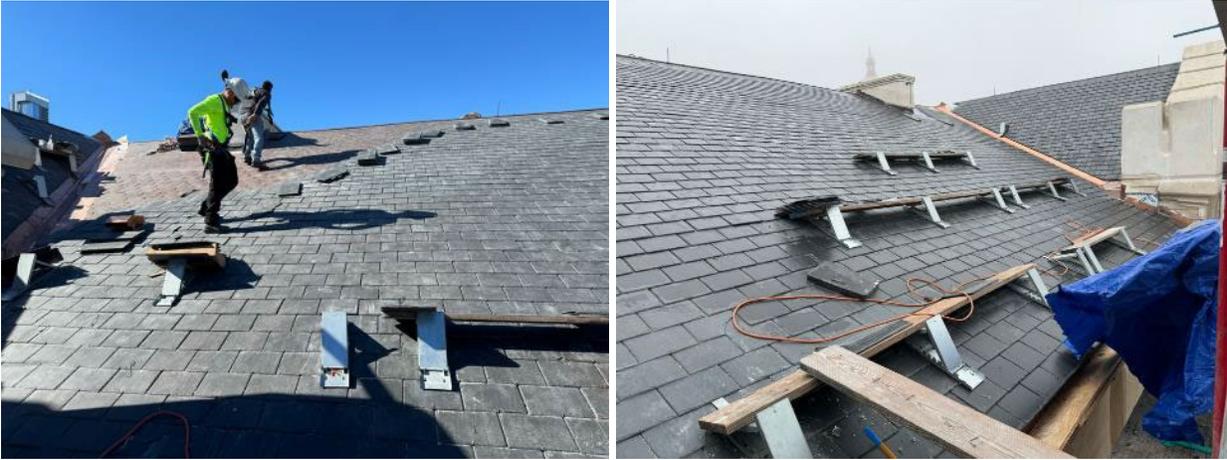
Slate is being installed on the East slope of the building.
