**State Preservation Board**

**Texas Capitol Roof Replacement and Rehabilitation Update 5/2/2023**

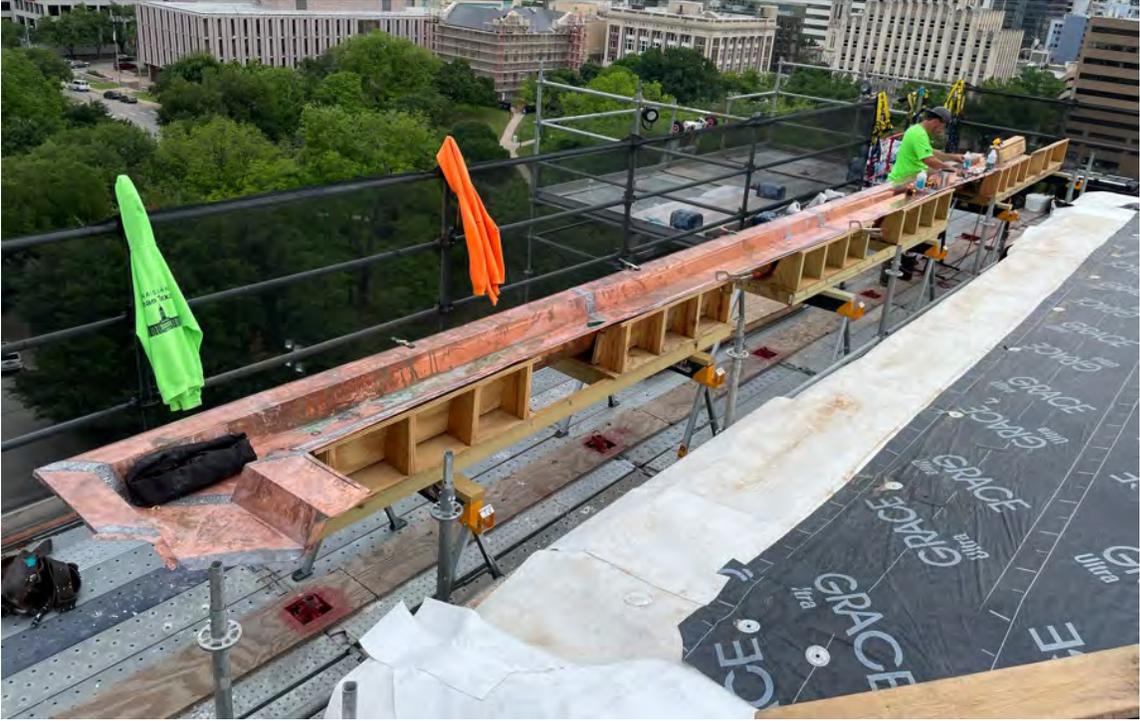
Much of the gutters are being soldered in pre-formed in jigs off the roof, to minimize fire risk from being soldered directly on the historic wood deck.

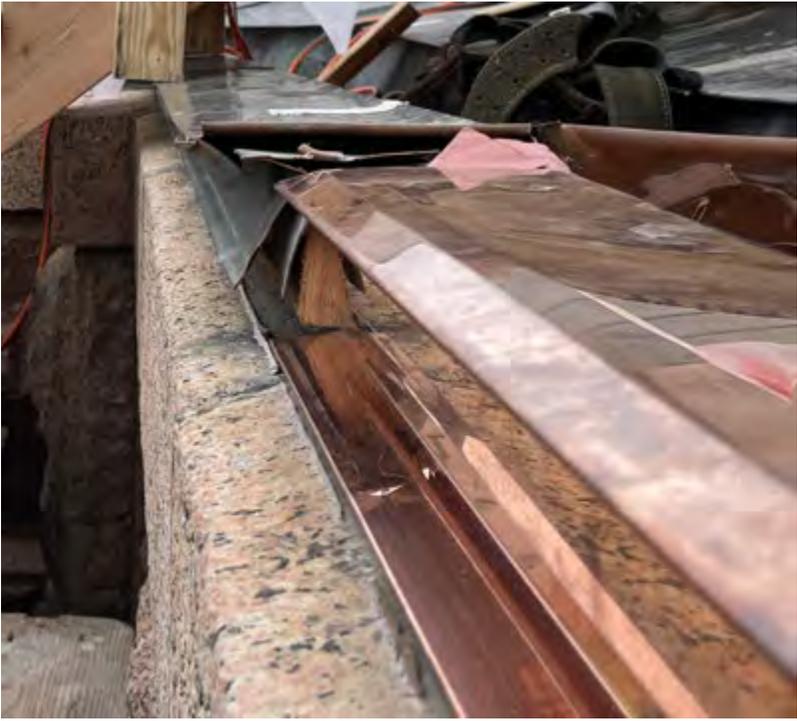
The outside edge of the gutter will be slightly lower in profile than the 1949 roof.

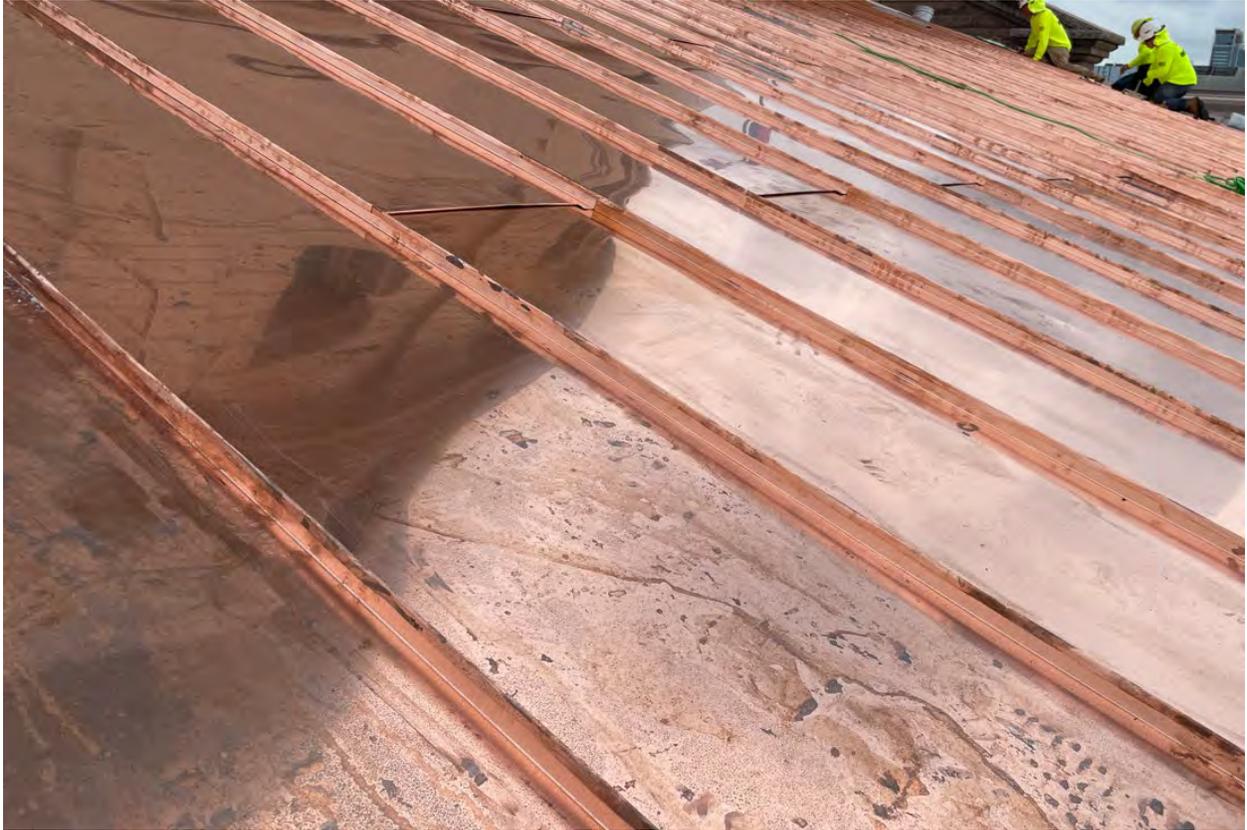
The copper is darkening quickly. Rain and dew is accelerating the process. In the image below, the shiny section beyond was placed in the afternoon after a rain. The darker section in the foreground was placed that same morning.

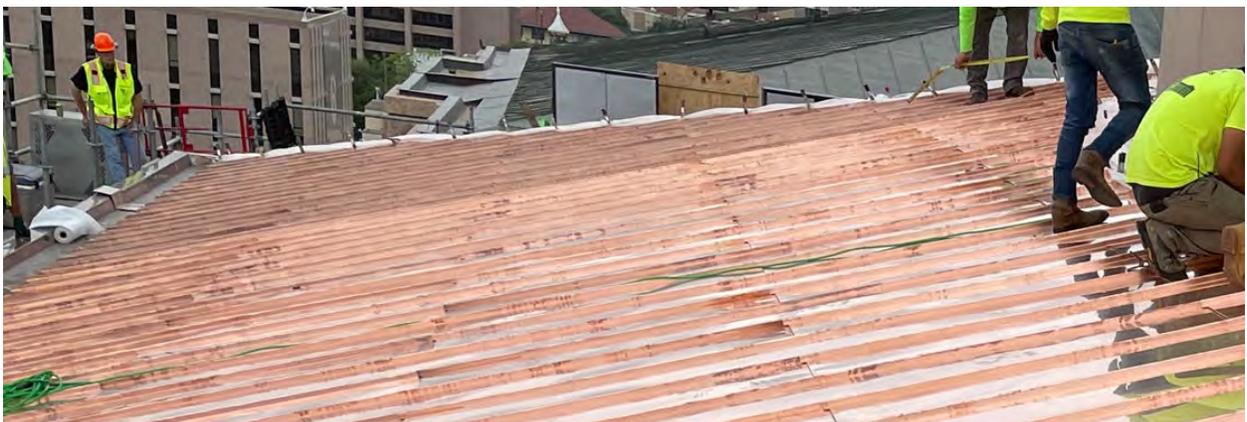
The darker section can be seen in the distance, here, to see the difference one rain event makes.

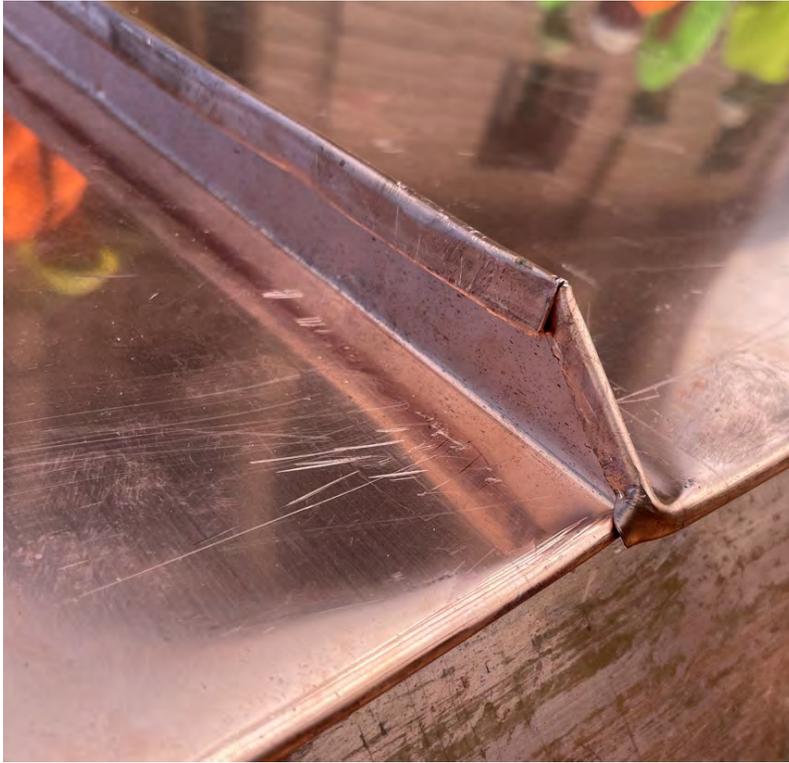
The new standing seams are being wrapped with an overlap to seal them from wind-blown rain,

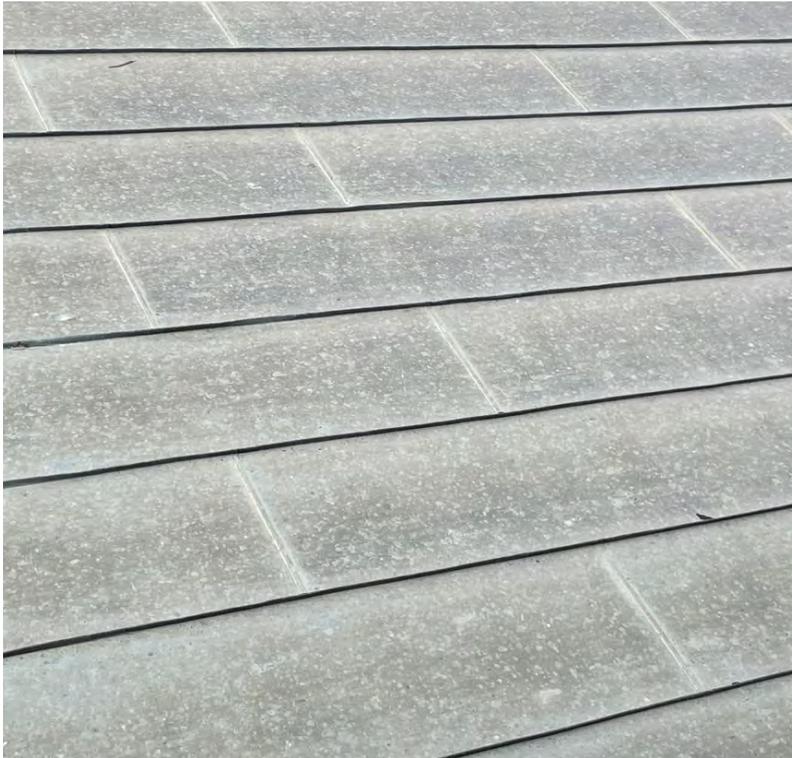
The “transverse seams” (perpendicular to the standing seams) will be more pronounced than in the 1949 roof, which had very tight, 3/4” flat seams.

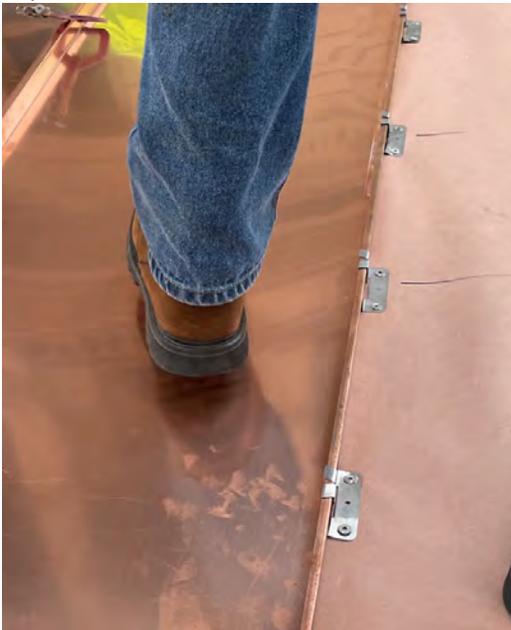
Expansion cleats:

Each 10 feet length of metal “pan” can expand and contract up to  $\frac{1}{4}$  inch in temperature extremes, which adds up to a lot of movement on a roof this size between a 0 degree day and a sunny summer day when the roof surface can reach 150 degrees. Some of the “cleats” which hold the standing seam to the deck will allow the roof to slide underneath, others will hold the pans tight to the deck, to control the direction of movement. Locations of fixed cleats were carefully selected to allow the large planes of roofing to move in a controlled way to minimize warping or “oilcanning” of the sheet metal, and minimize stress on soldered joints, as the roof moves around in temperature extremes.

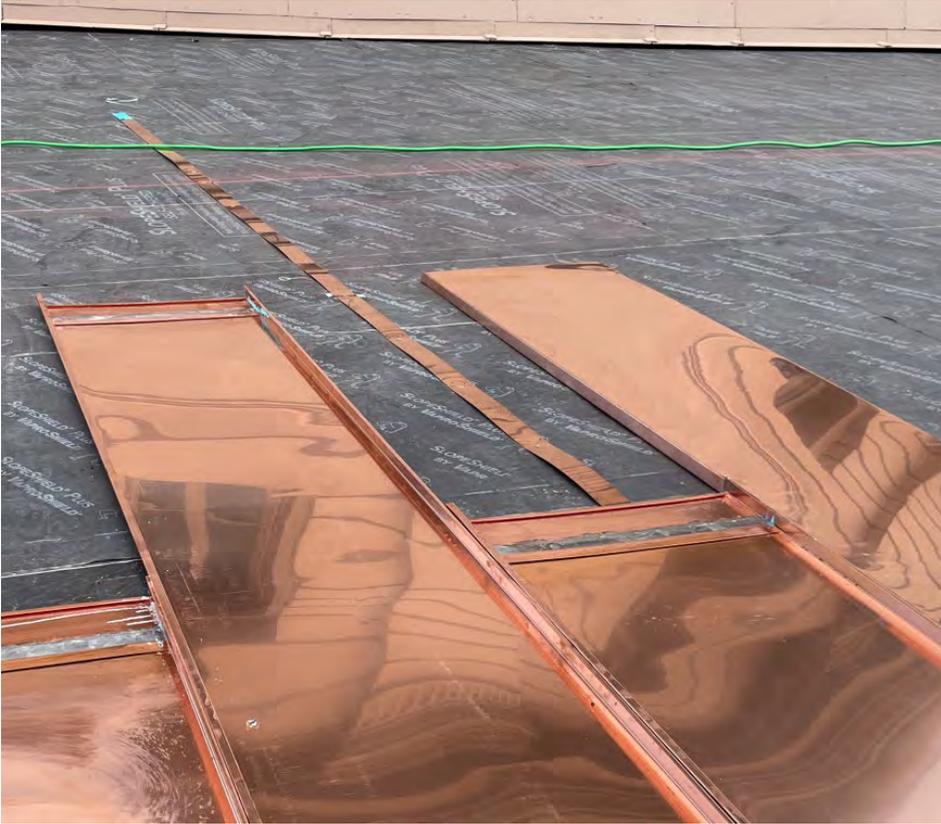
To ensure the roof copper is electrically grounded, properly bonded copper strips are being placed under the standing seam roof, passing through the roof deck at key locations.

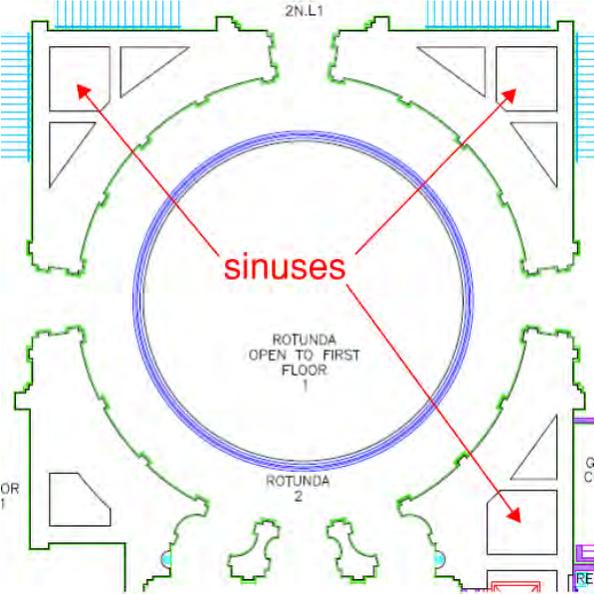
After passing through the roof, the leads will be tied to vertical grounding wires inside the hidden corners, or “sinuses,” of the stone walls of the rotunda, which provide a straight path to solid ground, with the path protected by stone on all sides.

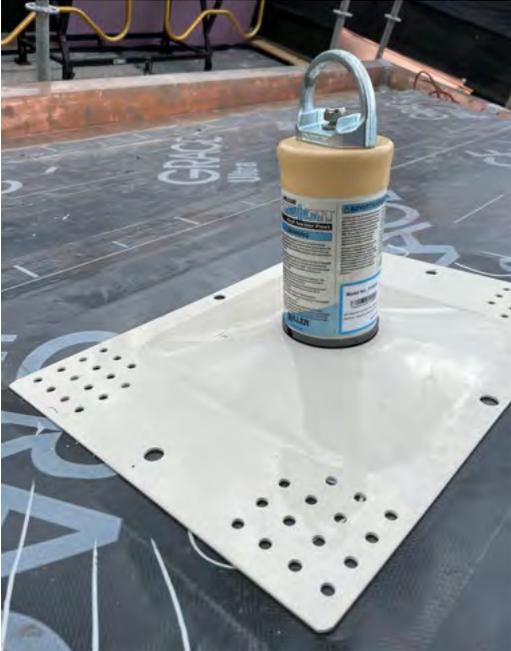
Fall protection elements are being incorporated into the roof for the first time, allowing for safe and regular inspections and gutter cleanings, and more affordable access for repairs.

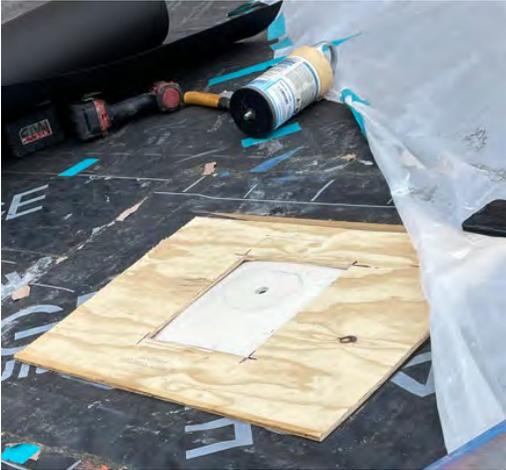
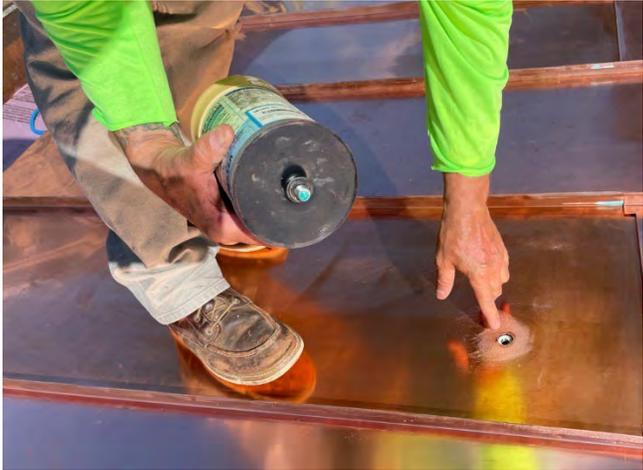
These anchors are being installed from below the roof, allowing them to be built into the historic wrought iron roof structure in a way that provides sufficient load capacity for their function. The anchors are removable, and the attachment points will be covered with low-profile caps when not in use, to minimize their visual impact.
